CRUACH CLENAMACRIE WIND FARM

APPENDIX 12.1 TRANSPORT ASSESSMENT - PART 2

Abnormal Indivisible Load Route Survey

December 2023

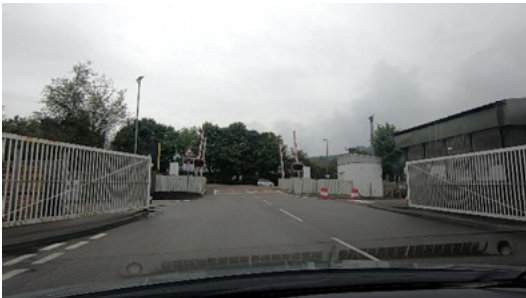
POI	Key Constraint	Details
1	<p>Corpach Harbour</p>

<p>Loads will exit Corpach Harbour in reverse and turn right onto the A830 eastbound.</p> <p>A swept path assessment has been undertaken and indicates that loads will overrun and oversail the northern verge of the A830 where load bearing surfaces should be laid, and the existing kerb protected. The area should be cleared of obstructions and parking should be suspended during deliveries. The fence, trees and one lighting column should be removed. Third party land is required.</p> <p>Communication with Network Rail is required.</p> <p>Swept path assessment SK01 is included in Appendix B.</p>
2	<p>Banavie Swing Bridge</p>  	<p>Loads will proceed on the A830.</p> <p>Loads will cross the bridge at caution and will advise the swing bridge control room that loads will be passing prior to them leaving Corpach.</p>
3	<p>Blar Mhor Roundabout</p>  	<p>Loads will take the second exit at the roundabout to continue on the A830 via a contraflow manoeuvre.</p> <p>A swept path assessment has been undertaken and indicates that loads will oversail the right-hand verge on entry to the roundabout where one road sign and two lighting columns should be removed.</p> <p>Loads will oversail the central island where one set of lit chevron signs and two private signs should be removed.</p> <p>Loads will also oversail the western verge upon exiting the roundabout, where the verge should be levelled and one lighting column and one private road sign should be removed.</p> <p>Swept path assessment SK02 is included in Appendix B.</p>

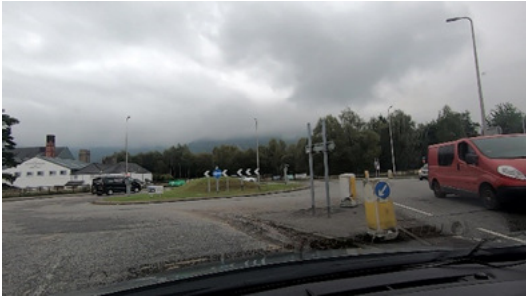
POI	Key Constraint	Details
4	<p>A830 / A82 Roundabout</p>

<p>Loads will take the second exit at the roundabout to join the A82 southbound via a contraflow manoeuvre.</p> <p>A swept path assessment has been undertaken and indicates that loads will oversail the northern verge on approach to the roundabout, where two lighting columns and one road sign should be removed. The bridge parapet will be oversailed and third party land is required.</p> <p>Loads will oversail the entry splitter island where the bollards and one road sign should be removed. Loads will then oversail the central island where two chevron signs and one private sign should be removed.</p> <p>Loads will then oversail the inside of the junction where three lighting columns, two road signs, trees, vegetation, one traffic signal, one call post and the guardrail should be removed. Loads will oversail the safety barrier and junction box. A land ownership review should be undertaken at this location.</p> <p>Swept path assessment SK03 is included in Appendix B.</p>

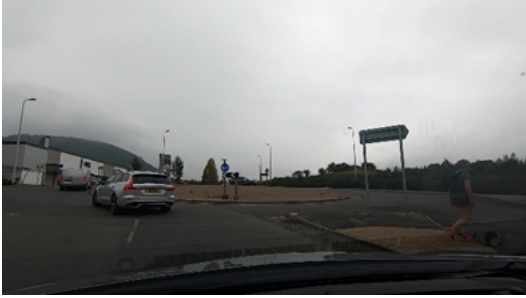
5	<p>A82 / North Road Roundabout</p>

<p>Loads will take the second exit at the roundabout to continue on the A82.</p> <p>A swept path assessment has been undertaken and indicates that loads will overrun through the centre of the roundabout island where a load bearing surface should be laid and two sets of lit chevron signs should be removed.</p> <p>Loads will also oversail the exit arm splitter island where one road sign and one bollard should be removed.</p> <p>Swept path assessment SK04 is included in Appendix B.</p>

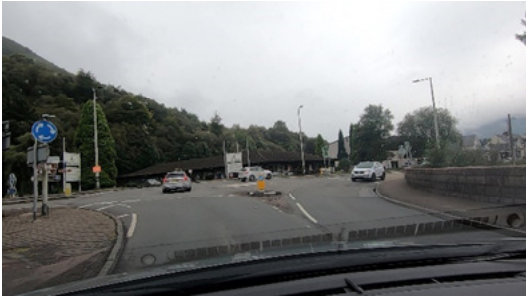
POI	Key Constraint	Details
6	<p>Belford Road Roundabout</p>

<p>Loads will take the third exit at the roundabout to continue on the A82 via a contraflow manoeuvre.</p> <p>A swept path assessment has been undertaken and indicates that loads will oversail the eastern bridge parapet into third party land. Trees, vegetation, two road signs, one lit road sign and two lighting columns should be removed.</p> <p>The temporary splitter island on the approach should be removed along with the bollard. Loads should be raised using suspension settings to allow oversail of the bridge parapet on the inside of the right bend where trees should be trimmed and two road signs, one lit road sign and one lighting column should be removed. Third party land is required.</p> <p>Loads will overrun and oversail the exit arm splitter island and southern footway where load bearing surfaces should be laid and one road sign, one lighting column and two bollards should be removed.</p> <p>Loads will also overrun and oversail the verges of the following left bend, where a load bearing surface should be laid on the northern verge and one lighting column should be removed. Kerbs should be protected.</p> <p>Swept path assessment SK05 is included in Appendix B.</p>

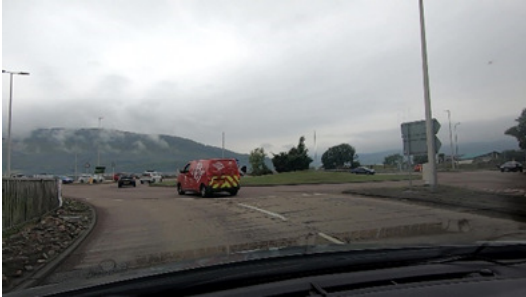
7	<p>Belford Road / A82 Roundabout</p>

<p>It is proposed that loads will approach the roundabout on the opposite side of the carriageway.</p> <p>A swept path assessment has been undertaken and indicates that loads will cross the central reserve in advance of the roundabout where a load bearing surface should be laid. One lighting column, one bollard and one road sign should be removed. The blade tip will over-sail the north-eastern footway where two lighting columns and two road signs should be removed.</p> <p>Loads will oversail the verge on the inside of the roundabout where three lighting columns, one lit road sign, a section of fencing and trees and vegetation to be removed. The blade tip will over-sail southern edge of the roundabout, where one lit road sign and one private road sign are to be removed.</p> <p>Loads will also oversail the southern verge of the exit arm, where one road sign, one lit road sign, one lighting column and one bollard should be removed.</p> <p>Swept path assessment SK06 is included in Appendix B.</p>

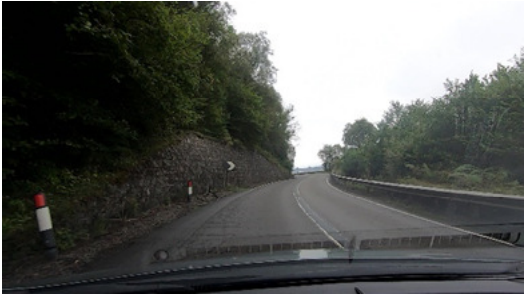
POI	Key Constraint	Details
14	<p>A82 Northeast of Corran</p>

<p>Loads will continue on the A82.</p> <p>A swept path assessment has been undertaken and indicates that loads will oversail both verges through the first bend. The blade will over-sail a series of bollards on the outside of the bend. Loads will oversail the safety barrier and the stone wall on the inside of the bend. Vegetation should be trimmed and one road sign removed. Third party land is required.</p> <p>Loads will oversail the inside verge through the second bend where vegetation and trees should be trimmed. Loads should be raised to their highest suspension setting to oversail the safety barrier.</p> <p>Swept path assessment SK12 is included in Appendix B.</p>
15	<p>A82 Bends, Corran</p>

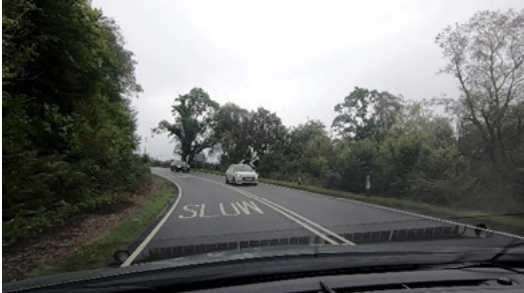
<p>Loads will continue on the A82.</p> <p>A swept path assessment has been undertaken and indicates that loads will oversail both verges through this location. Vegetation and trees should be trimmed through the first two bends.</p> <p>On the second set of bends bollards should be over-sailed on the western verge through the double bend.</p> <p>Vegetation should be trimmed on the eastern verge through the first bend and the clearance to the rock face should be confirmed on a topographical survey.</p> <p>Swept path assessment SK13 is included in Appendix B.</p>

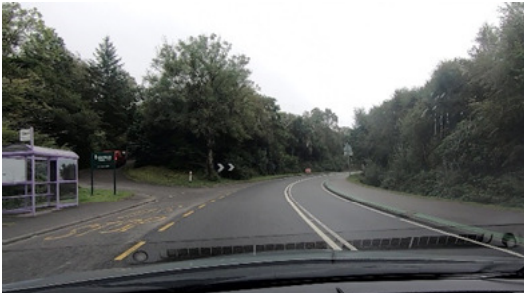
16	<p>A82 Bends, Corran</p>

<p>Loads will continue on the A82.</p> <p>A swept path assessment has been undertaken and indicates that loads will oversail both verges through the bends, where bollards will be over-sailed on the outside verges of both bends. At the first bend, two roads signs should be removed and vegetation trimmed on the inside verge. Vegetation should be trimmed on the inside verge of the send bend.</p> <p>Swept path assessment SK14 is included in Appendix B.</p>

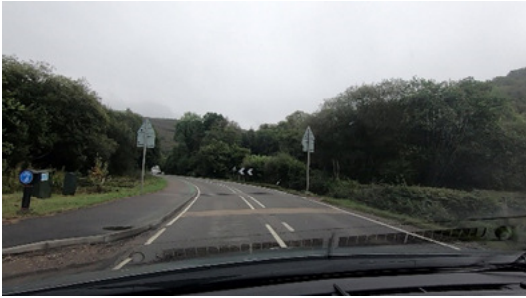
POI	Key Constraint	Details
17	A82 Double Bend, Keppanach

<p>Loads will continue on the A82.</p> <p>A swept path assessment has been undertaken and indicates that loads will oversail both verges of the carriageway where trees and vegetation should be trimmed on both verges. One bollard should be oversailed on the western verge on approach to the bend. Two road signs, two private signs and one set of chevron signs should be removed from the north-eastern verge. Third party land is required.</p> <p>One metal pole should be removed on the inside verge on the bend.</p> <p>Swept path assessment SK15 is included in Appendix B.</p>
18	A82 Right Bend, Keppanach

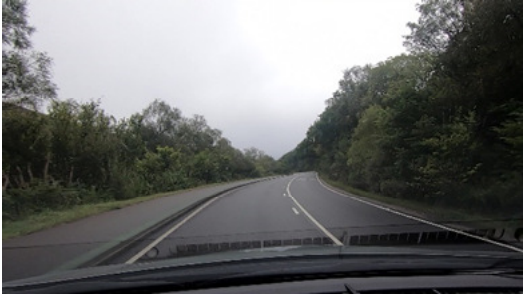
<p>Loads will continue on the A82.</p> <p>A swept path assessment has been undertaken and indicates that loads will oversail both verges of the bend. Vegetation and trees should be trimmed on the inside verge.</p> <p>Swept path assessment SK16 is included in Appendix B.</p>

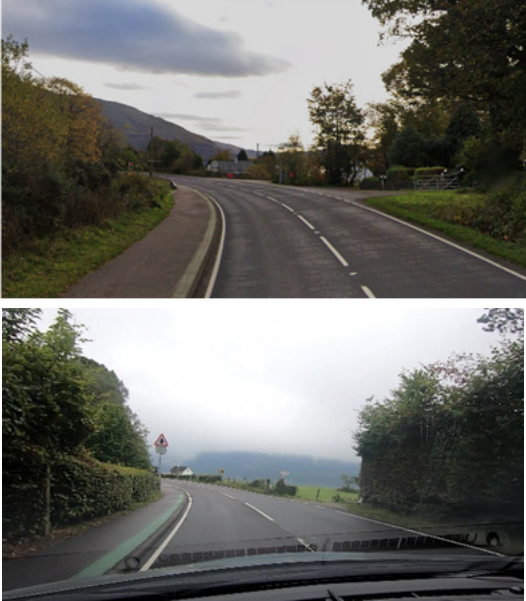
19 & 20	A82 Left Bends, Onich

<p>Loads will continue on the A82.</p> <p>A swept path assessment has been undertaken and indicates that loads will oversail both verges of the carriageway where and vegetation should be trimmed on the western verge through both bends. Bollards should be oversailed on the western verge through the second bend where one road sign should be removed on the eastern verge.</p> <p>Swept path assessment SK17 is included in Appendix B.</p>

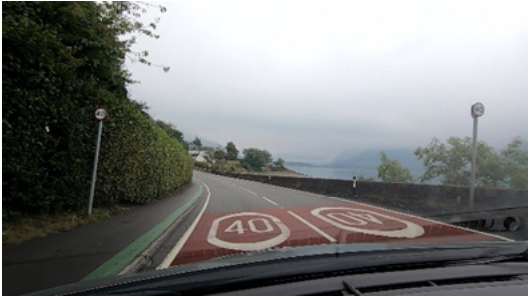
POI	Key Constraint	Details
21	<p>A82 Bends, Onich</p>

<p>Loads will continue on the A82.</p> <p>A swept path assessment has been undertaken and indicates that loads will over-sail both verges through the first left hand bend, though no works are required. Loads will over-sail the inside verge of the right-hand bend where a section of fencing should be removed along with one tree. Third party land is required.</p> <p>Loads will over-sail the inside verge of the second left-hand bend though no mitigation is required.</p> <p>Swept path assessment SK18 is included in Appendix B.</p>
22	<p>A82 Double Bend, Onich</p>

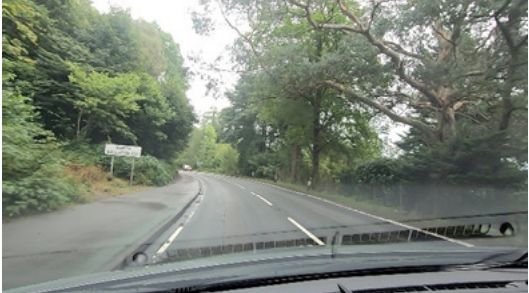
<p>Loads will continue on the A82.</p> <p>A swept path assessment has been undertaken and indicates that loads will oversail both verges of the carriageway through the bends, where vegetation should be trimmed on the south western verge through the final bend.</p> <p>Swept path assessment SK19 is included in Appendix B.</p>

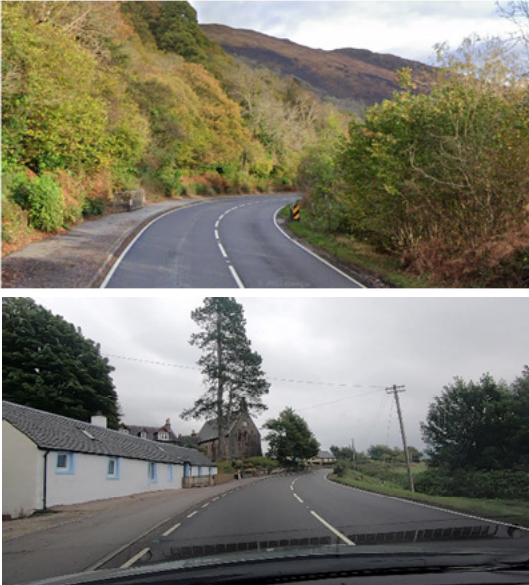
23 & 24	<p>A82 North of Ballachulish</p>

<p>Loads will continue on the A82.</p> <p>A swept path assessment has been undertaken and indicates that loads will over-sail the southern verge through the first right bend where vegetation should be trimmed and loads raised to clear the stone wall.</p> <p>Parking should be suspended during movements on the north eastern verge of the last bend.</p> <p>Loads will oversail the inside of the last bend, where two utility posts should be relocated and loads raised to clear the stone wall. Third party land will be required.</p> <p>Swept path assessment SK20 is included in Appendix B.</p>

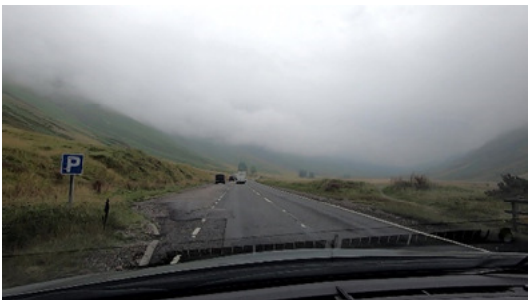
26	<p>North East of Loch Achtriochtan</p>

<p>Loads will continue on the A82.</p> <p>The road surface was noted to be in a poor state of repair at this location. It is recommended that discussions are held with Transport Scotland to ensure repairs are completed prior to deliveries.</p>

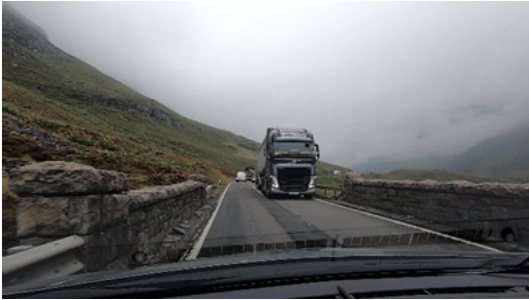
POI	Key Constraint	Details
27	<p>A82 North of Three Sisters of Glencoe</p>

<p>Loads will continue on the A82.</p> <p><i>OS base mapping does not identify the road edge at this location. An indicative road edge has been provided for illustration only. Mitigation should be confirmed through a test run.</i></p> <p>The blade lifting trailer should be raised through this section. All overhead utility obstructions should be relocated.</p> <p>A swept path assessment has been undertaken and indicates that loads will oversail the northern verge through the right bend where bollards, one road sign and one chevron sign should be oversailed.</p> <p>Loads will oversail the southern verge through the right bend where one road sign should be removed and the safety barrier over-sailed.</p> <p>Loads will then oversail the southwestern verge through the left bend where chevron signs, bollards and the safety barrier will be oversailed. Third party land is required</p> <p>The rock face should be regraded on the inside of the left bend subject to confirmation on a topographical survey. Loads will also oversail the safety barrier on both sides of the carriageway following this bend.</p> <p>Third party land is required throughout this section on both sides of the road.</p> <p>Swept path assessment SK22 is included in Appendix B.</p>

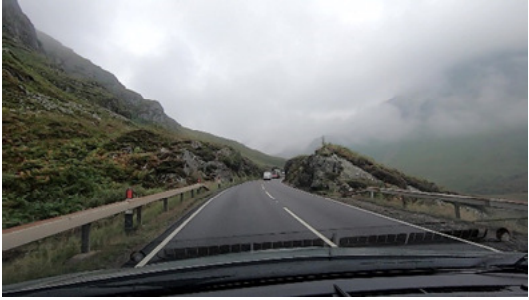
28	<p>A82 East of Three Sisters of Glencoe Car Park</p>

<p>Loads will continue on the A82.</p> <p><i>OS base mapping does not identify the road edge at this location. An indicative road edge has been provided for illustration only. Mitigation should be confirmed through a test run or on a topographical survey base plan.</i></p> <p>The blade lifting trailer should be raised through this section. Any overhead utilities should be relocated.</p> <p>A swept path assessment has been undertaken and indicates that loads will over-sail both verges of the right bend where the rock faces should be regraded subject to confirmation on a topographical survey.</p> <p>Loads will over-sail both verges of the following left-hand bend where the rock face should be regraded subject to confirmation on a topographical survey on the inside verge and the safety barrier should be over-sailed on the outside verge.</p> <p>Swept path assessment SK23 is included in Appendix B.</p>

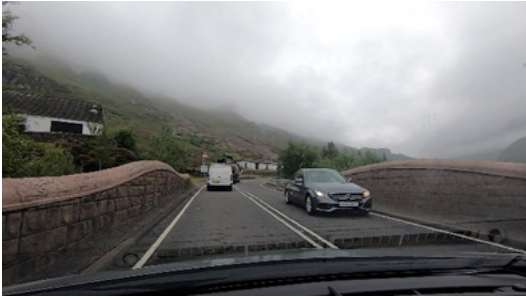
POI	Key Constraint	Details
29	<p>A82 East of Aonach Eagach Car Park</p>

<p>Loads will continue on the A82.</p> <p>The blade lifting trailer should be raised through this section. Any overhead utilities should be relocated.</p> <p>A swept path assessment has been undertaken and indicates that loads should be set to highest suspension to oversail safety barrier on the inside of the bend.</p> <p>Third party land will be required through this section.</p> <p>Swept path assessment SK24 is included in Appendix B.</p>
30	<p>A82 West of Ralston Cairn</p>

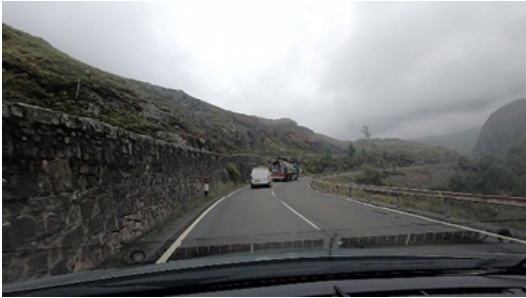
<p>Loads will continue on the A82.</p> <p><i>OS base mapping does not identify the road edge at this location. An indicative road edge has been provided for illustration only. Mitigation should be confirmed through a test run.</i></p> <p>The blade lifting trailer should be raised through this section. Any overhead utilities should be relocated.</p> <p>A swept path assessment has been undertaken and indicates that loads will over-sail the northern verge through the right bend where the wall and all street furniture will be oversailed.</p> <p>Loads should be set to highest suspension to oversail safety barrier on the inside of the right bend.</p> <p>The rock face on the inside of the left bend should be regraded subject to confirmation on a topographical survey.</p> <p>Swept path assessment SK25 is included in Appendix B.</p>

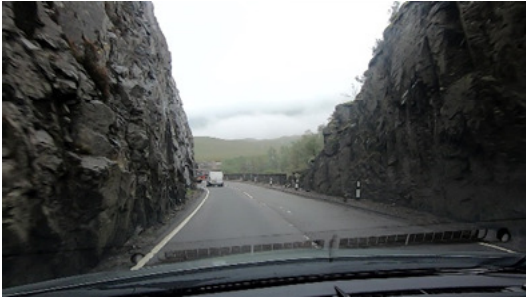
31	<p>A82 Glencoe Waterfall</p>

<p>Loads will continue on the A82.</p> <p>The blade lifting trailer should be raised through this extremely constrained section.</p> <p>A swept path assessment has been undertaken and indicates that the rock face on the outside of the left bend should be regraded subject to detailed design reviews.</p> <p>Swept path assessment SK26 is included in Appendix B.</p>

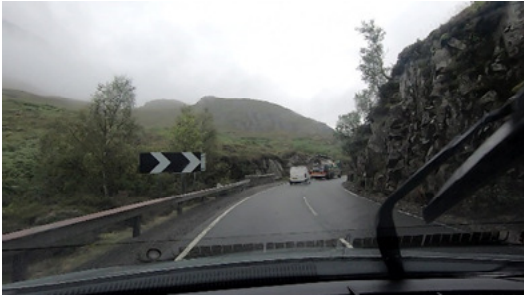
POI	Key Constraint	Details
32	<p>A82 Northwest of Glencoe Waterfall</p>

<p>Loads will continue on the A82.</p> <p>The blade lifting trailer should be raised through this section.</p> <p>A swept path assessment has been undertaken and indicates that loads will over-sail both verges, though no physical mitigation is required.</p> <p>Following this section, the blade tip can be lowered.</p> <p>Swept path assessment SK27 is included in Appendix B.</p>
33	<p>A82 West of Glencoe Valley Viewpoint</p>

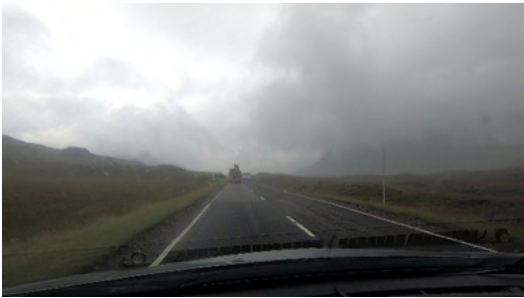
<p>Loads will continue on the A82.</p> <p>The road surface was noted to be in a poor state of repair at this location. It is recommended that discussions are held with Transport Scotland to ensure repairs are completed prior to deliveries.</p>
<p>Blade loads will be transferred to a Superwing Carrier trailer to the east of Glencoe. The exact location of the transfer station will be detailed once the required land option has been secured by the developer.</p>

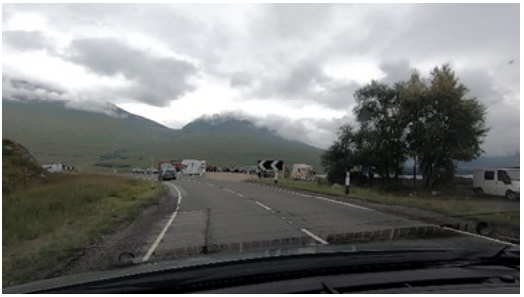
34	<p>A82 Loch Tulla Viewpoint</p>

<p>Loads will continue on the A82.</p> <p>A swept path assessment has been undertaken and indicates that loads will oversail the inside of the left bend where three snow poles should be removed.</p> <p>Loads will oversail the western verge on approach to the left bend where two snow poles, one road sign and one set of chevron signs should be removed. Bollards will be over-sailed. Parking should be suspended in the oversail area in the layby during deliveries.</p> <p>Loads will oversail the inside verge through the right where one snow pole should be removed.</p> <p>Swept path assessment SK28 is included in Appendix B.</p>
35	<p>A82 Left Bend, Northwest of Achallader</p>

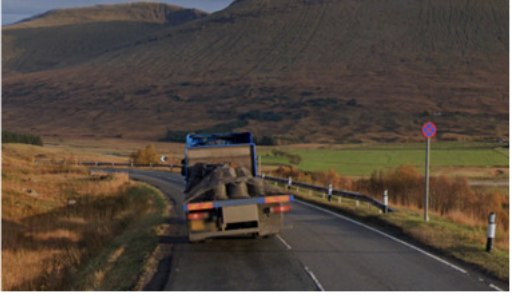
<p>Loads will continue on the A82.</p> <p><i>OS base mapping does not identify the road edge at this location. An indicative road edge has been provided for illustration only. Mitigation should be confirmed through a test run.</i></p> <p>Loads will oversail both verges of the carriageway where two poles should be removed from the northern verge.</p> <p>Swept path assessment SK29 is included in Appendix B.</p>

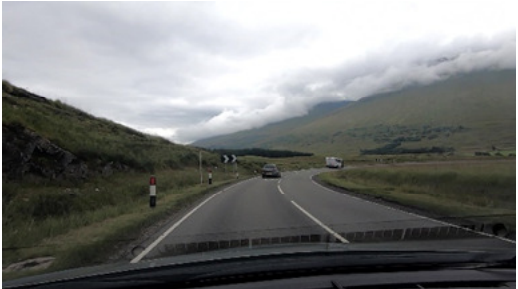
POI	Key Constraint	Details
36	<p>A82 Northwest of Achallader</p>

<p>Loads will continue on the A82.</p> <p><i>OS base mapping does not identify the road edge at this location. An indicative road edge has been provided for illustration only. Mitigation should be confirmed through a test run.</i></p> <p>A swept path assessment has been undertaken and indicates that loads will oversail both verges through the bend. Three sets of chevron signs and three snow poles should be removed from the outside of the bend. The blade will oversail all bollards. Third party land is required.</p> <p>Loads will oversail the inside of the bend where four snow poles should be removed.</p> <p>Swept path assessment SK30 is included in Appendix B.</p>
37	<p>A82 South of Auch</p>

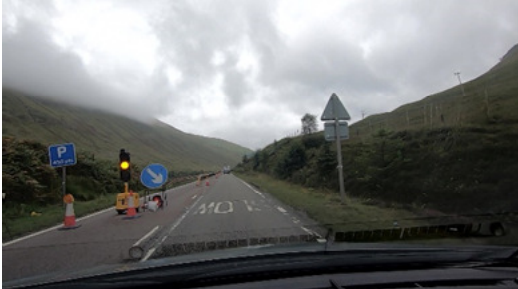
<p>Loads will continue on the A82.</p> <p>Ongoing road works were noted at this location during the site visit. Confirmation that all works have finished should be sought before movements commence.</p>

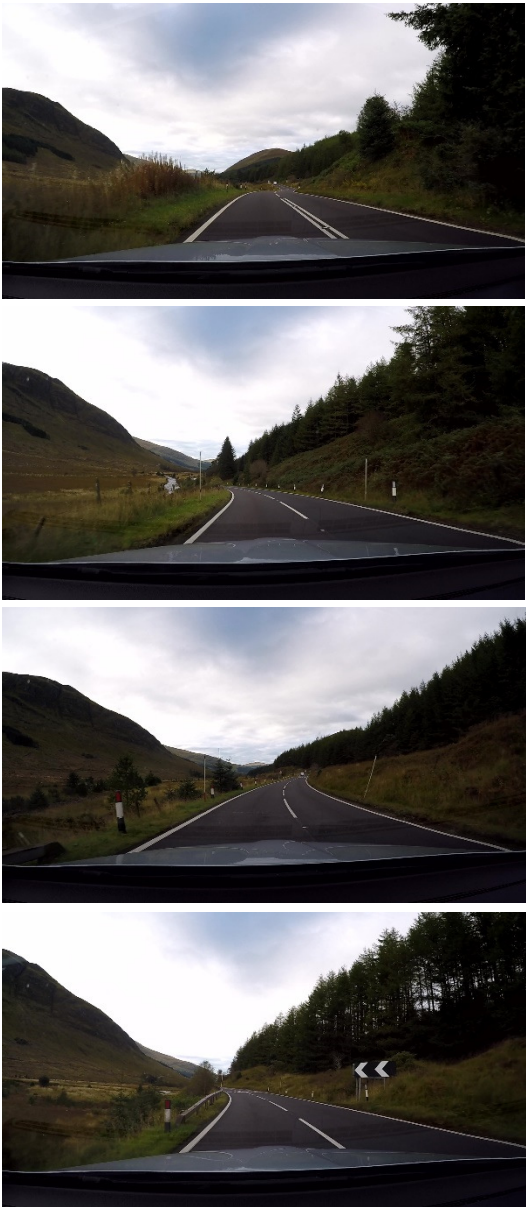
POI	Key Constraint	Details
41	<p>A85 Arrivain</p>

<p>Loads will continue on the A85.</p> <p>Parking in the layby on the northern side of the road to be suspended during deliveries.</p> <p>The vertical profile of the road at this location is pronounced and should be reviewed during the test run stage to ascertain if tar wedges will be required to extend the vertical curvature of the road and prevent grounding.</p>
42	<p>A85 Glenloch Crossing</p>

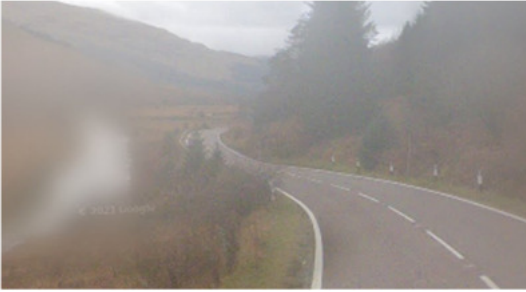
<p>Loads will continue on the A85.</p> <p><i>OS base mapping does not identify the road edge at this location. An indicative road edge has been provided for illustration only. Mitigation should be confirmed through a test run.</i></p> <p>A swept path assessment has been undertaken and indicates that loads will over-sail both verges through the series of bends where three metal poles should be removed.</p> <p>The blade tip will over-sail multiple bollards on the outside verge of the left-hand bend where one road sign and one chevron sign should be removed.</p> <p>Swept path assessment SK32 is included in Appendix B.</p>

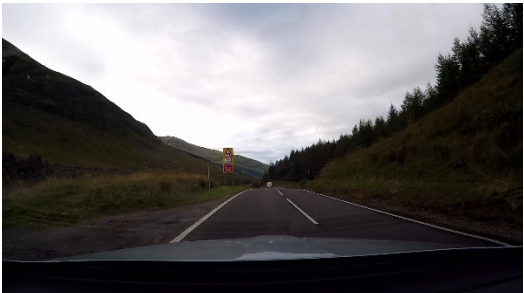
POI	Key Constraint	Details
43	<p>A85 Southwest of Arrivain</p>

<p>Loads will continue on the A85.</p> <p>The vertical profile of the road at this location is pronounced and should be reviewed during the test run stage to ascertain if tar wedges will be required to extend the vertical curvature of the road and prevent grounding.</p>
44	<p>A85 Bends Southwest of Arrivain</p>

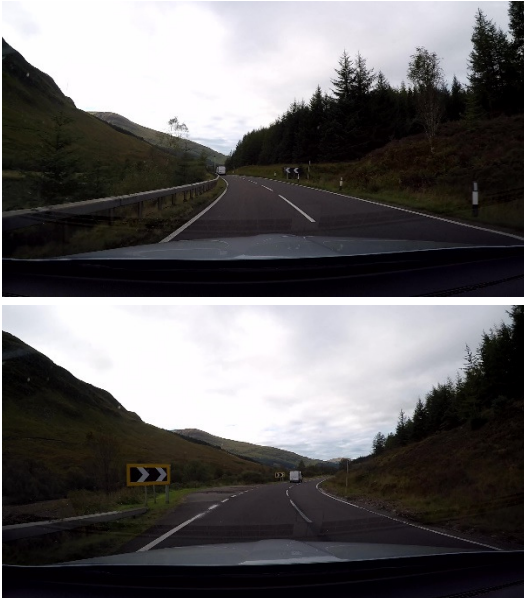
<p>Loads will continue on the A85.</p> <p><i>OS base mapping does not identify the road edge at this location. An indicative road edge has been provided for illustration only. Mitigation should be confirmed through a test run.</i></p> <p>A swept path assessment has been undertaken and indicates that loads will oversail both verges of the carriageway through this location where the safety barrier will be oversailed on the eastern verge and five snow poles should be removed on the western verge.</p> <p>Trees and vegetation should be removed on the inside verge of the final bend where three further snow poles should be removed.</p> <p>Swept path assessment SK33 is included in Appendix B.</p>

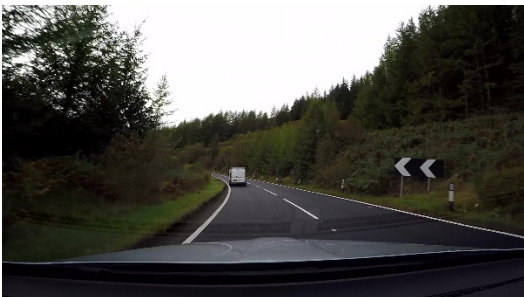
45	<p>A85 Bends Southwest of Arrivain</p>

<p>Loads will continue on the A85.</p> <p><i>OS base mapping does not identify the road edge at this location. An indicative road edge has been provided for illustration only. Mitigation should be confirmed through a test run.</i></p> <p>A swept path assessment has been undertaken and indicates that loads will oversail the inside of the bend where one snow pole should be removed. Loads will oversail the safety barrier where third party land is required. Vegetation and trees should be trimmed.</p> <p>Loads will oversail the north-western verge where one chevron sign should be removed and bollards oversailed.</p> <p>Swept path assessment SK34 is included in Appendix B.</p>

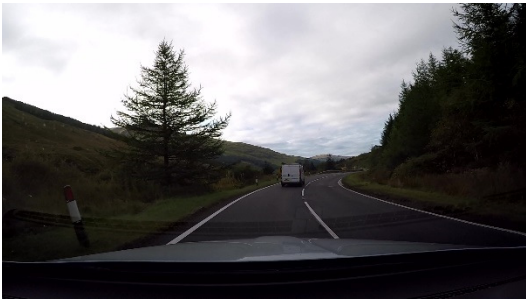
POI	Key Constraint	Details
46	<p>A85 Bends Southwest of Arrivain</p>

<p>Loads will continue on the A85.</p> <p><i>OS base mapping does not identify the road edge at this location. An indicative road edge has been provided for illustration only. Mitigation should be confirmed through a test run.</i></p> <p>A swept path assessment has been undertaken and indicates that loads will oversail both verges of the bend. On the outside of the right bend two sets of chevron signs and two snow poles should be removed. The blade will oversail the safety barrier and bollards.</p> <p>Two snow poles should be removed from the inside of the right bend where third party land will be required. Loads will over-sail the safety barrier on the inside of the left bend.</p> <p>Swept path assessment SK35 is included in Appendix B.</p>
47	<p>A85 Northeast of Glen Lochy Car Park</p>

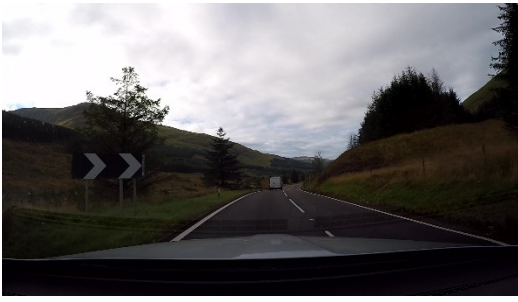
<p>Loads will continue on the A85.</p> <p>The vertical profile of the road at this location is pronounced and should be reviewed during the test run stage to ascertain if tar wedges will be required to extend the vertical curvature of the road and prevent grounding. Loads should be set on a higher suspension setting to reduce the need for physical works at this location.</p>

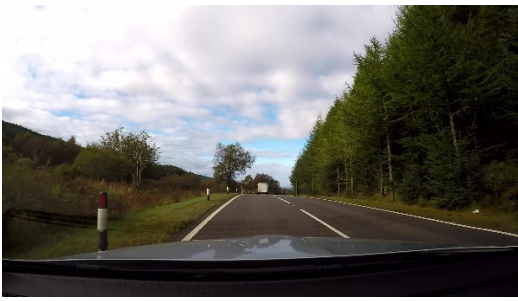
48	<p>A85 Southwest of Glen Lochy Car Park</p>

<p>Loads will continue on the A85.</p> <p><i>OS base mapping does not identify the road edge at this location. An indicative road edge has been provided for illustration only. Mitigation should be confirmed through a test run.</i></p> <p>A swept path assessment has been undertaken and indicates that loads will over-sail on both verges through the bends where two snow poles should be removed.</p> <p>The vertical profile of the road at this location is pronounced and should be reviewed during the test run stage to ascertain if tar wedges will be required to extend the vertical curvature of the road and prevent grounding.</p> <p>Swept path assessment SK36 is included in Appendix B.</p>

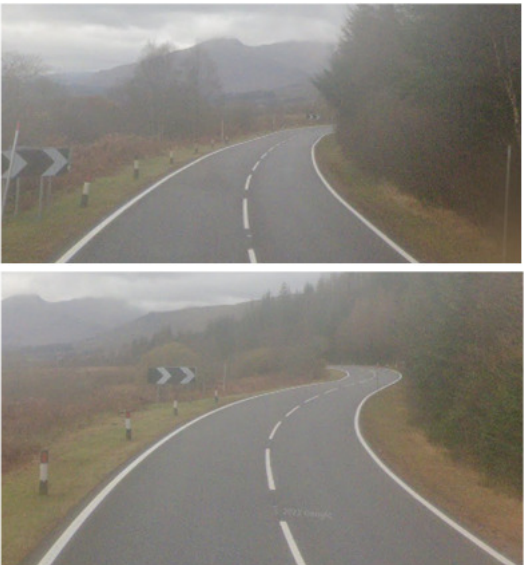
POI	Key Constraint	Details
49	A85 Northeast of Succoth Lodge

<p>Loads will continue on the A85.</p> <p><i>OS base mapping does not identify the road edge at this location. An indicative road edge has been provided for illustration only. Mitigation should be confirmed through a test run.</i></p> <p>A swept path assessment has been undertaken and indicates that loads will over-sail on both verges through the double bends where multiple snow poles should be removed on the northern verge. Trees and vegetation should be trimmed.</p> <p>Swept path assessment SK37 is included in Appendix B.</p>
50, 51	A85 East of Strone Hill Car Park

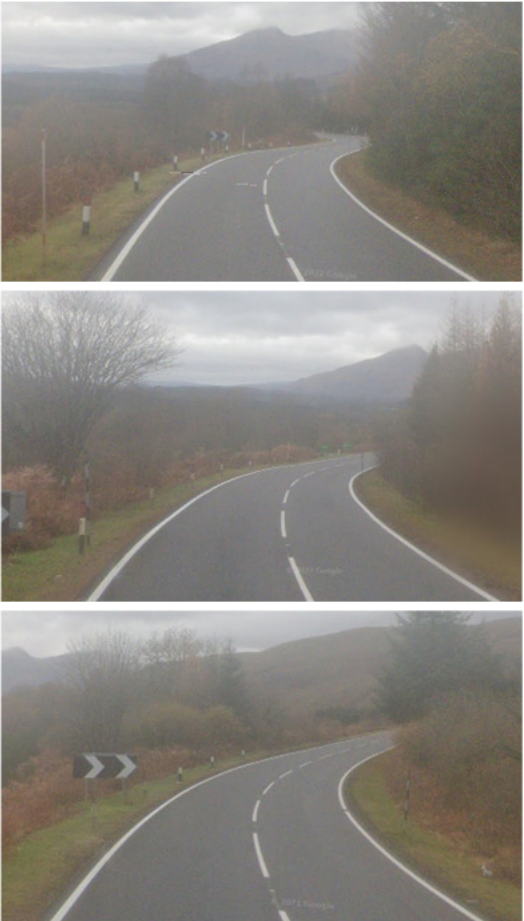
<p>Loads will continue on the A85.</p> <p><i>OS base mapping does not identify the road edge at this location. An indicative road edge has been provided for illustration only. Mitigation should be confirmed through a test run.</i></p> <p>A swept path assessment has been undertaken and indicates that loads will over-sail on both verges through the bends where multiple snow poles should be removed and bollards over-sailed. Trees and vegetation should be trimmed on the northern verge through the final right-hand bend.</p> <p>Swept path assessment SK38 is included in Appendix B.</p>

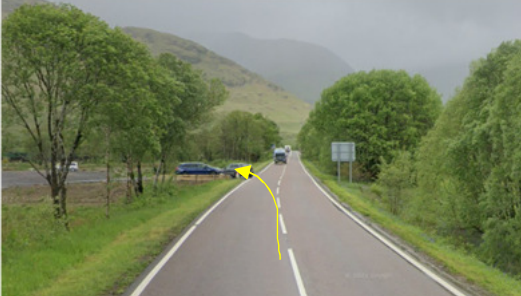
57	<p>A85 Blade Change Park East of Drishaig</p>

<p>Loads will turn off the A85 left into a car park to change onto a blade lift adaptor and will re-join the A85 heading westbound. This is due to extreme constraints located at POI 59. The parking area would then be used as a blade transition area.</p> <p><i>OS base mapping does not identify the road edge at this location. An indicative road edge has been provided for illustration only. Mitigation should be confirmed through a test run.</i></p> <p>A swept path assessment has been undertaken and indicates loads will over-sail and over-run on the southern edge of the car park where trees and vegetation should be removed and load bearing surface provided. Third party land will be required.</p> <p>Loads will over-run and over-sail the northern edge of the car park where a load bearing surface will be required to be laid and one bollard and a section of fencing is to be removed. Third party land will be required.</p> <p>Swept path assessment SK43 is included in Appendix B.</p>

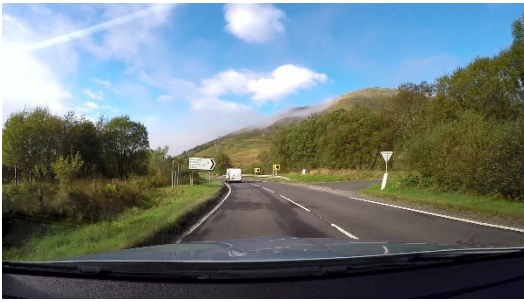
POI	Key Constraint	Details
58	<p>A85 Drishaig</p>

<p>Loads will continue on the A85.</p> <p>The blade lifting trailer should be raised through this section. Any overhead utilities should be relocated.</p> <p>A swept path assessment has been undertaken and indicates that loads will oversail both verges of the carriageway where the blade tip will over-sail all street furniture.</p> <p>Swept path assessment SK44 is included in Appendix B.</p>
59	<p>A85 Creag a' Gheoidh</p>

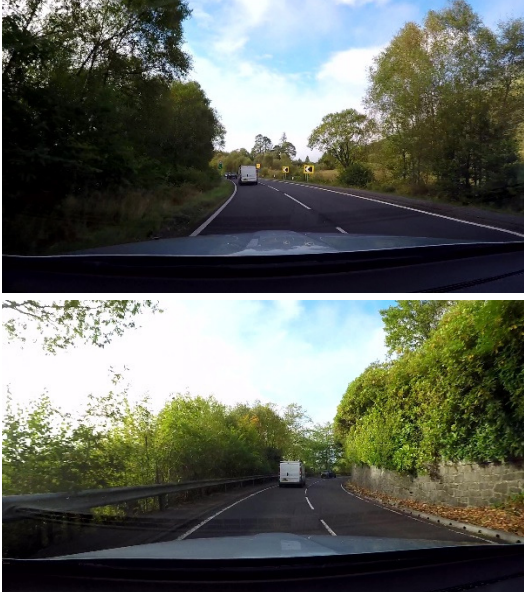
<p>Loads will continue on the A85.</p> <p>The blade lifting trailer should be raised through this section. Any overhead utilities should be relocated.</p> <p>A swept path assessment has been undertaken and indicates that loads will oversail and over-run the outside verge through the right bend where a load bearing surface should be laid and third party land is required. The blade will over-sail the safety barrier and all street furniture, vegetation and trees should be trimmed.</p> <p>Vegetation should be trimmed on the inside of the right bend and the clearance to the stone wall should be confirmed on a topographical survey.</p> <p>Loads will over-sail both verges of the following left-hand bend, though no physical mitigation is required.</p> <p>Swept path assessment SK45 is included in Appendix B.</p>

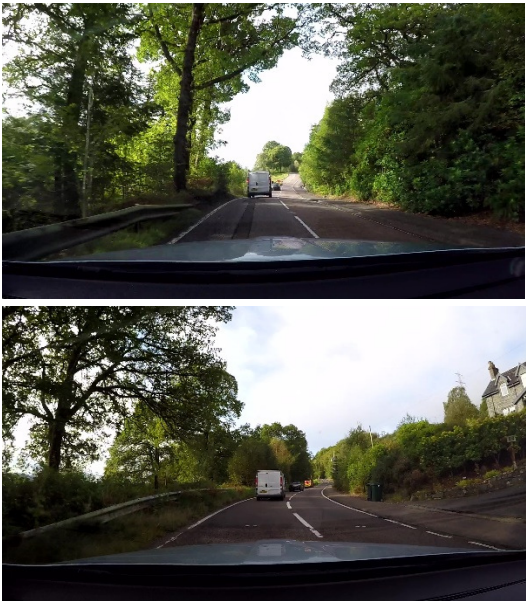
POI	Key Constraint	Details
62	<p>A85 St Conan's Kirk</p>

<p>Loads will continue on the A85.</p> <p>The blade lifting trailer should be raised through this section. Any overhead utilities should be relocated.</p> <p>A swept path assessment has been undertaken and indicates that loads will oversail both verges of the carriageway, however no physical works are required.</p> <p>The vertical profile of the road at this location is pronounced and should be reviewed during the test run stage to ascertain if tar wedges will be required to extend the vertical curvature of the road and prevent grounding.</p> <p>Swept path assessment SK48 is included in Appendix B.</p>
63	<p>A85 Railway Bridge at Innis Chonain</p>

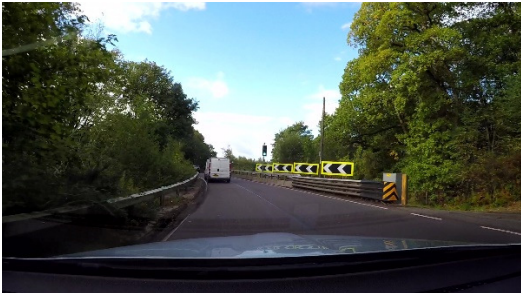
<p>Loads will continue on the A85 over the railway bridge.</p> <p><i>OS base mapping does not identify the road edge at this location. An indicative road edge has been provided for illustration only. Mitigation should be confirmed through a test run.</i></p> <p>The blade lifting trailer should be raised through this section. Any overhead utilities should be relocated.</p> <p>A swept path assessment has been undertaken and indicates that loads will oversail the northern verge on approach to the bridge where bollards should be over-sailed, and one utility pole should be removed.</p> <p>Loads will oversail sides of the bridge where loads should be set to their highest suspension setting to oversail the bridge parapet and safety barrier. Third party land is required.</p> <p>One utility pole, one traffic signal, trees and vegetation should be removed on the south eastern verge over the bridge. A further traffic signal, chevron signs, trees and vegetation should be removed on the northwestern verge over the bridge.</p> <p>A revised assessment on a topographical survey base plan is recommended. Early engagement with Network Rail is required at this location.</p> <p>Swept path assessment SK49 is included in Appendix B.</p>

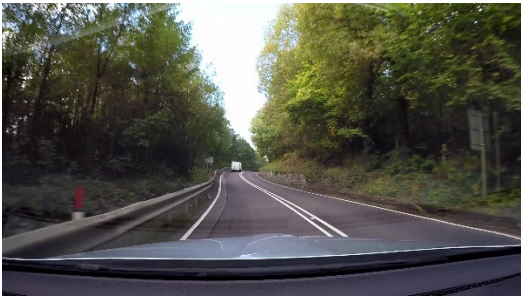
POI	Key Constraint	Details
64	<p>A85 Innis Chonain</p>

<p>Loads will continue on the A85.</p> <p>The blade lifting trailer should be raised through this section. Any overhead utilities should be relocated.</p> <p>A swept path assessment has been undertaken and indicates that loads will oversail the southern verge through the left bend though no physical mitigation is required.</p> <p>Loads should be set to their highest suspension setting to oversail the retaining wall / embankment on the inside of the right bend.</p> <p>Swept path assessment SK50 is included in Appendix B.</p>
65	<p>A85 Southwest of Creag a' Bhodaich</p>

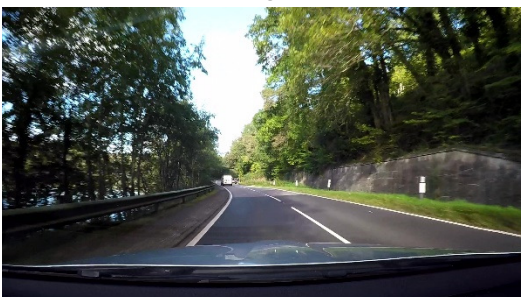
<p>Loads will continue on the A85.</p> <p>The blade lifting trailer should be raised through this section. Any overhead utilities should be relocated.</p> <p><i>Ariel mapping and OS mapping does not identify the road edge at this location. An indicative road edge has been provided for illustration only.</i></p> <p>A swept path assessment has been undertaken and indicates that loads will oversail the north eastern verge where the clearance to the retaining wall should be confirmed on a topographical survey. Bollards will be oversailed.</p> <p>Trees should be removed on the south western verge where third party land is required and the safety barrier oversailed.</p> <p>Swept path assessment SK51 is included in Appendix B.</p>

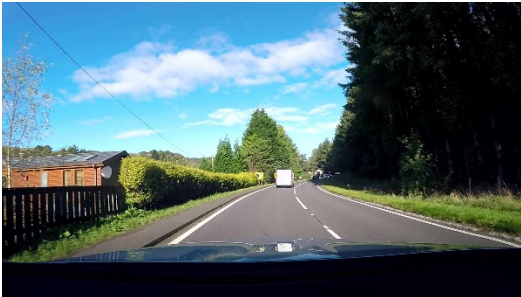
66	<p>A85 Loch Awe Holiday Park</p>

<p>Loads will continue on the A85.</p> <p>The blade lifting trailer should be raised through this section. Any overhead utilities should be relocated.</p> <p>A swept path assessment has been undertaken and indicates that loads will oversail both verges through the bends where the blade tip will over-sail all street furniture.</p> <p>Swept path assessment SK52 is included in Appendix B.</p>

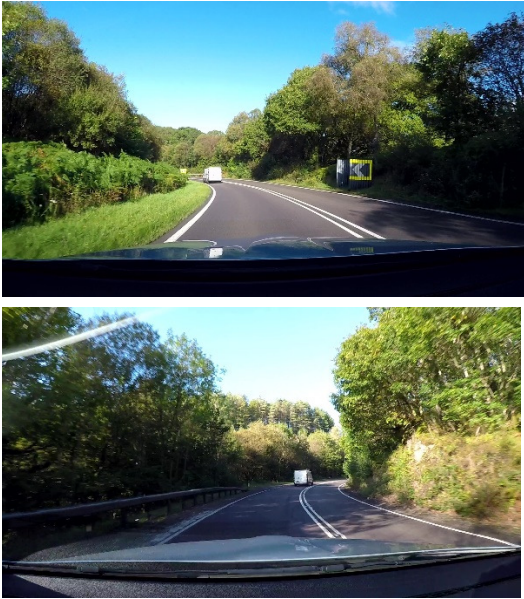
POI	Key Constraint	Details
71	A85 Railway / Allt Nathais Bridge

<p>Loads will continue on the A85.</p> <p>The blade should be raised through this section. Any overhead utilities should be relocated.</p> <p>A swept path assessment has been undertaken and indicates that loads will oversail both verges through the left bend though no physical mitigation is required. The blade tip should over-sail all street furniture.</p> <p>Loads will oversail both verges of the carriageway through the right bend where the embankment should be reprofiled and one road sign removed on the inside verge where third party land is required. Vegetation and trees should be trimmed.</p> <p>A revised assessment on a topographical survey base plan is recommended. Early engagement with Network Rail is also required at this location to agree the over-sail.</p> <p>Swept path assessment SK56 is included in Appendix B.</p>

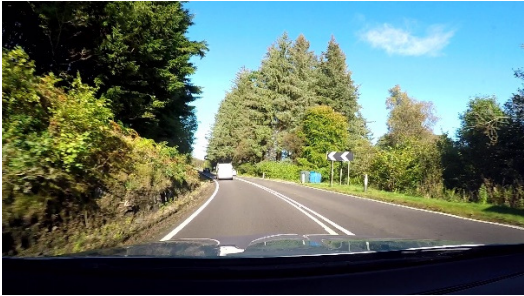
72	A85 Eltham Cottages

<p>Loads will continue on the A85.</p> <p>The blade lifting trailer should be raised through this section. Any overhead utilities should be relocated.</p> <p>A swept path assessment has been undertaken and indicates that loads will oversail the inside verge through the left bend though no physical mitigation is required.</p> <p>Swept path assessment SK57 is included in Appendix B.</p>
73	A85 Northeast of Dailnamac

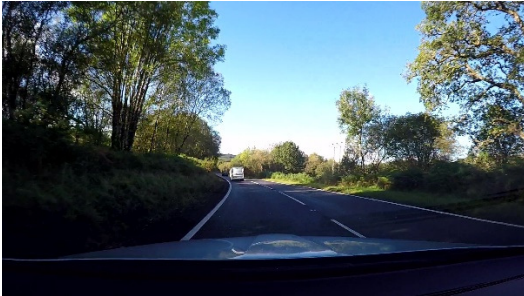
<p>The clearances to overhead power lines at this location should be reviewed with the utility provider prior to loads moving to ensure that there is sufficient head height and flashover protection for all temperature ranges.</p>
74	A85 Site Access

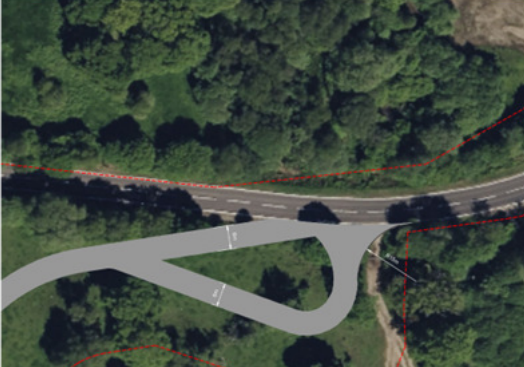
<p>Loads will turn left into the proposed site access junction at this location. Abnormal loads will use the ahead slip, which will be constructed out of different surfacing to the conventional bellmouth, which would be used by all other construction traffic.</p> <p>The abnormal lane would be coned off when not in use, during the construction phase to prevent use by other traffic.</p> <p>The new junction and access track should be constructed to manufacturer guidelines. The design of the junction is illustrated in the Transport Assessment.</p>
