CRUACH CLENAMACRIE WIND FARM

APPENDIX 9.1 PEAT SLIDE RISK ASSESSMENT

Cruach Clenamacrie Wind Farm: Peat Slide Risk Assessment

2760751-P9.1 (02)

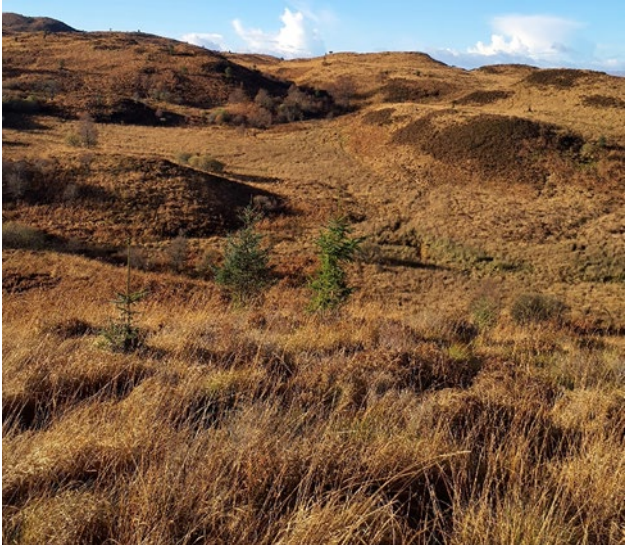
| | <p>C) View south from turbine T3, NGR NM 9423 3023.</p> <p>Photograph shows view across location of proposed track and turbine T4.</p> <p>The landscape is undulating, with many small hills rising steeply from areas of lower ground. A small tributary to Eas nam Meirleach (NGR NM 9440 3037) can be seen running north-east through the centre of the photo.</p> <p>Vegetation in this area is characterised by sedges and heather, with sparse conifers and native trees scattered throughout.</p> <p>Peat is mostly shallow here (<0.5m), with a few patches of deeper peat (0.5-4.5m) dispersed across the field of view. The deeper peat is predominantly associated with the watercourse.</p> |

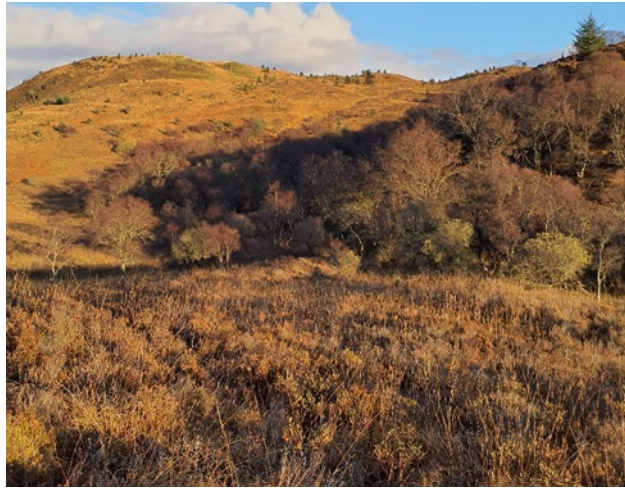
| | <p>D) View east from turbine T4, NGR NM 9439 2979.</p> <p>Photograph shows view east across Site looking up towards proposed location of turbine T6.</p> <p>The foreground shows vegetation consisting of sedges, grasses, heather, bog myrtle and Sphagnum while an area of native woodland is visible to the right-hand side. In the background, on the hillside, vegetation is characterised by sedges and heather with a scattering of conifers and other small trees.</p> <p>Peat in this area is predominantly shallow (< 1m).</p> |

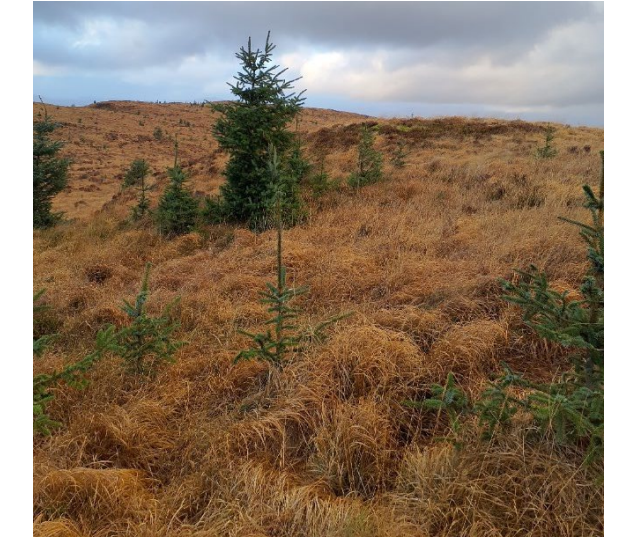
| | <p>E) View east from proposed access track, NGR NM 9344 2948.</p> <p>Photograph shows view east from the proposed access track, looking west towards the centre of the Site.</p> <p>Vegetation is dominated by grasses and there are young conifer trees scattered across the landscape with intermittent areas of heather.</p> <p>Like much of the Site, the landscape is undulating and hilly. This photograph was taken in a location where peat is generally under 0.5m, with pockets of deeper peat found on the hilly areas towards the back of the photograph.</p> |

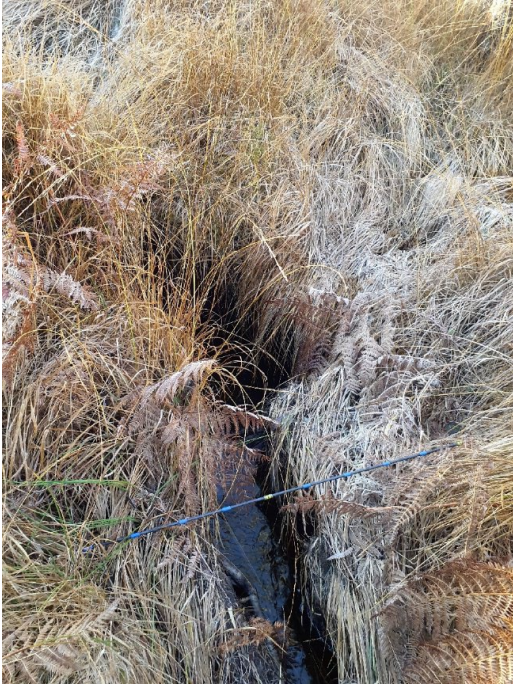
| | <p>I) Watercourse next to Turbine T4, NGR NM 9424 3020.</p> <p>Photograph shows watercourse crossing WC1 close to turbine T4 hardstanding. The watercourse is within a defined narrow channel approximately 0.3m wide.</p> <p>The vegetation along this part of the watercourse is predominantly grasses with some rushes and bracken present.</p> <p>At the crossing location, the peat is less than 0.5m deep. Surrounding areas have a similar pattern of peat distribution to the rest of the Site, with areas between 0.5-1m deep and pockets of deeper peat up to 5m.</p> |

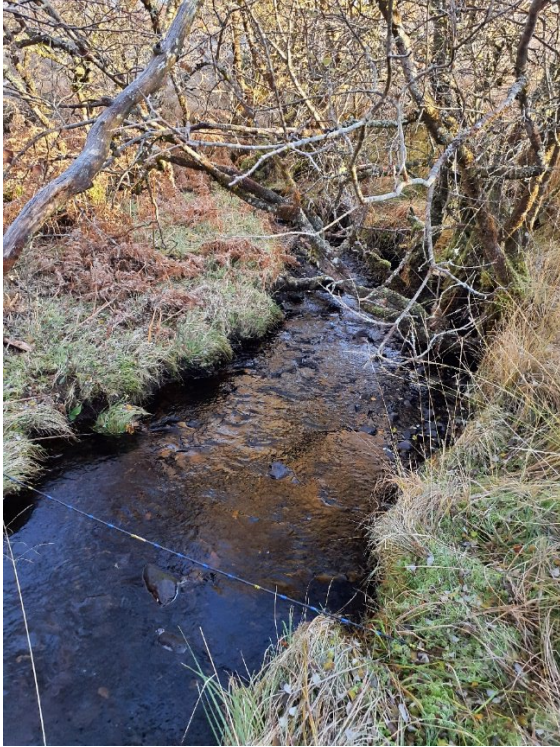
| | <p>J) Watercourse crossing along track to Turbine T3, NGR NM 9452 3047.</p> <p>Photograph shows watercourse crossing location along the track to Turbine T3. The watercourse is in a wide and well-defined channel approximately 1.5m wide and 0.2m deep.</p> <p>The vegetation along this part of the watercourse is predominantly grasses with some rushes and bracken present. Trees can be seen along the banks of the watercourse.</p> <p>There is little peat around this area, with most being under 0.5m deep.</p> |

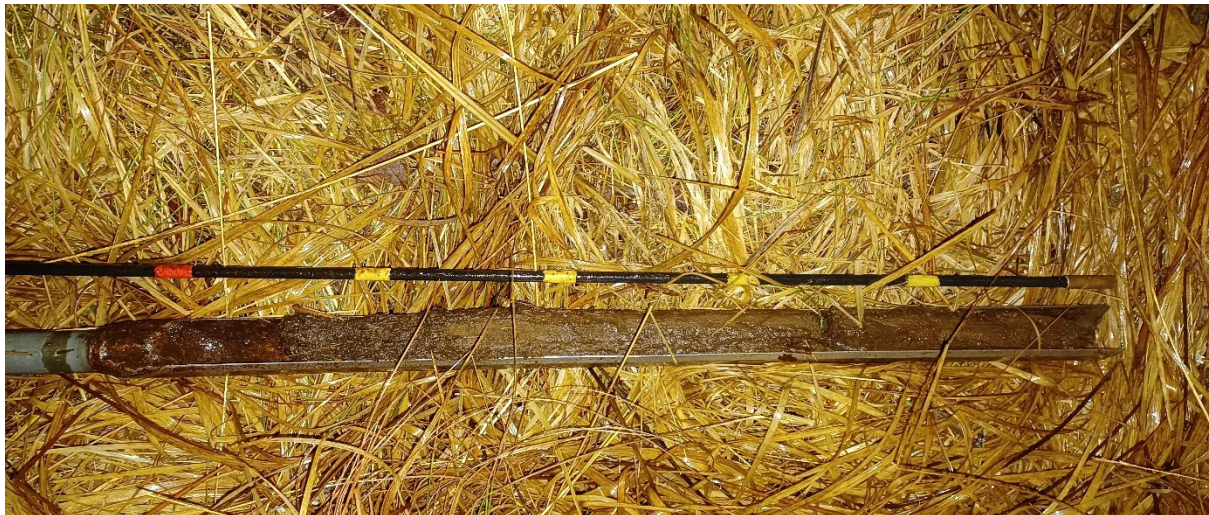
| Location: C1 | Depth: 0.00-0.50 m bgl | Date: 01/02/2024 |

Notes: Core interior showing fibrous, slightly decomposed peat.

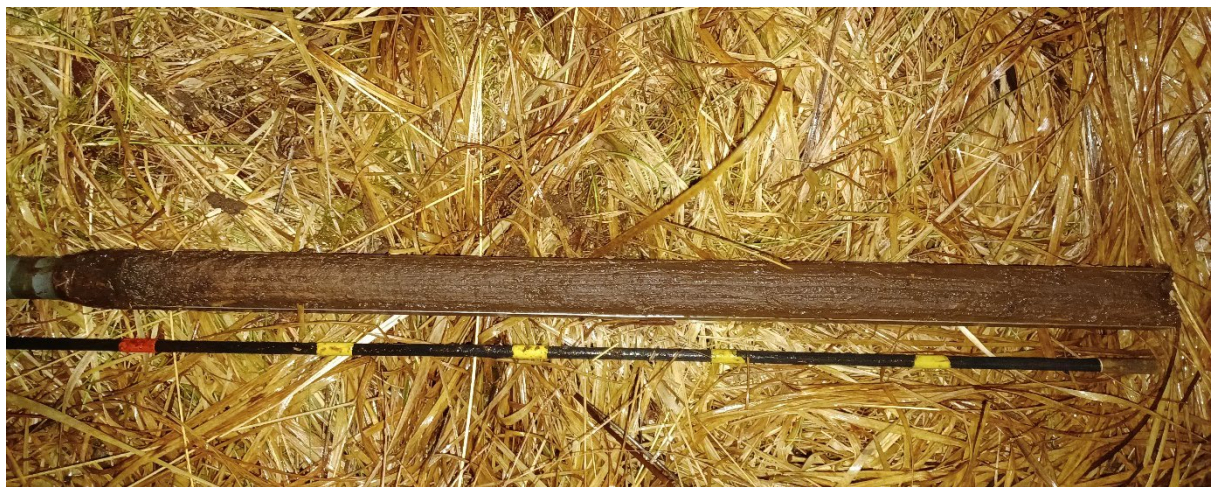
| Location: C1 | Depth: 0.50-1.00 m bgl | Date: 01/02/2024 |

Notes: Core interior showing moderately decomposed peat with indistinct plant structure.

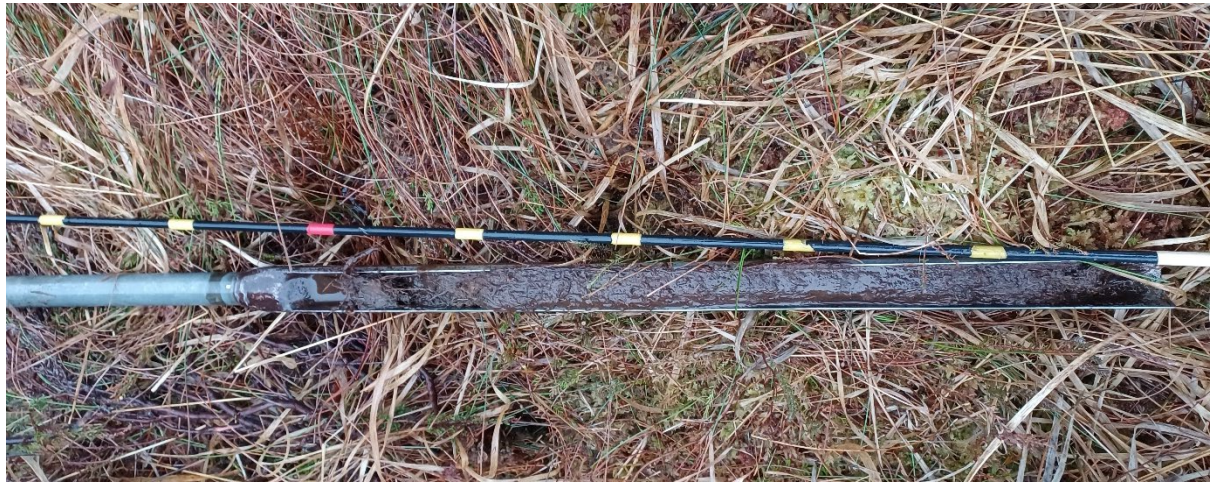
| Location: C2 | Depth: 0.00-0.50 m bgl | Date: 01/02/2024 |

Notes: Core interior showing almost entirely undecomposed peat with easily identifiable plant remains overlying almost entirely undecomposed peat to very slightly decomposed peat with identifiable plant remains.

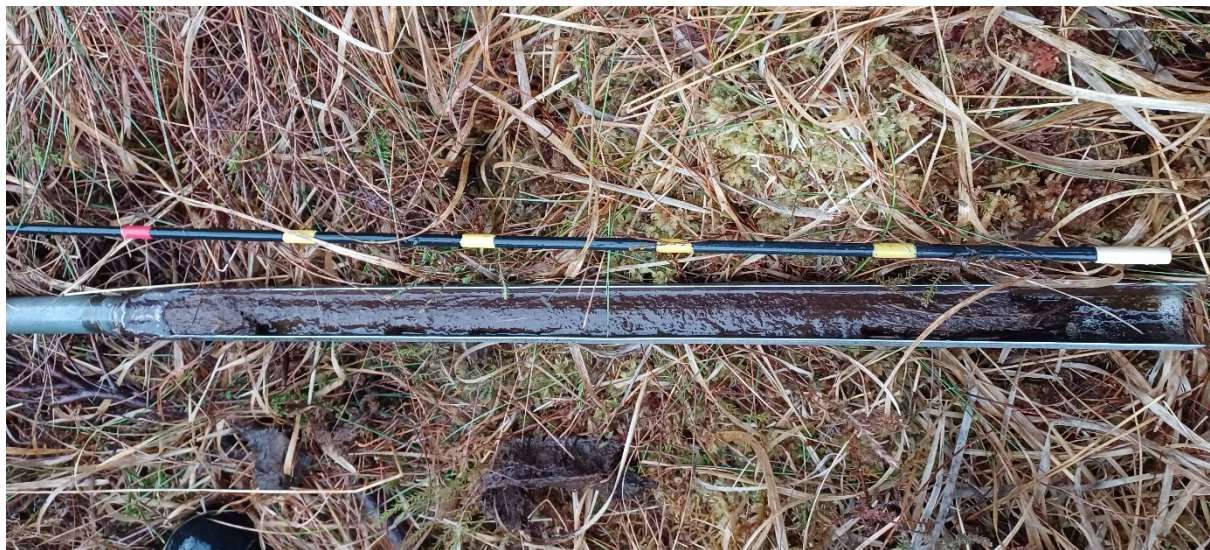
| Location: C2 | Depth: 0.50-1.00 m bgl | Date: 01/02/2024 |

Notes: Core interior showing moderately decomposed peat with indistinct plant structure overlying moderately highly decomposed peat with very indistinct plant structure.

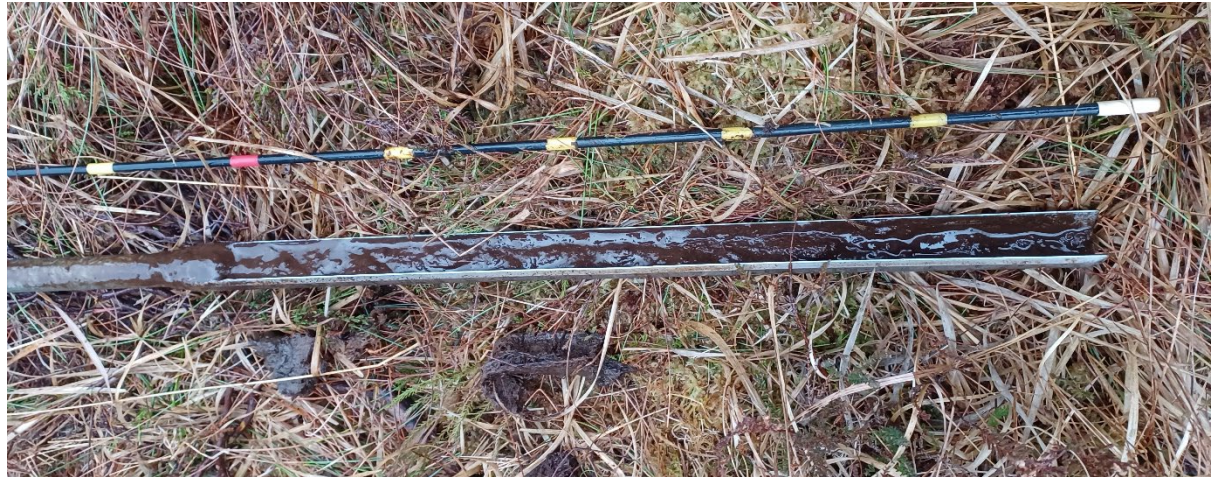
| Location: C2 | Depth: 1.00-1.50 m bgl | Date: 01/02/2024 |

Notes: Core interior showing highly decomposed peat with very faintly recognisable plant structure overlying very highly decomposed peat with very indistinct plant structure.

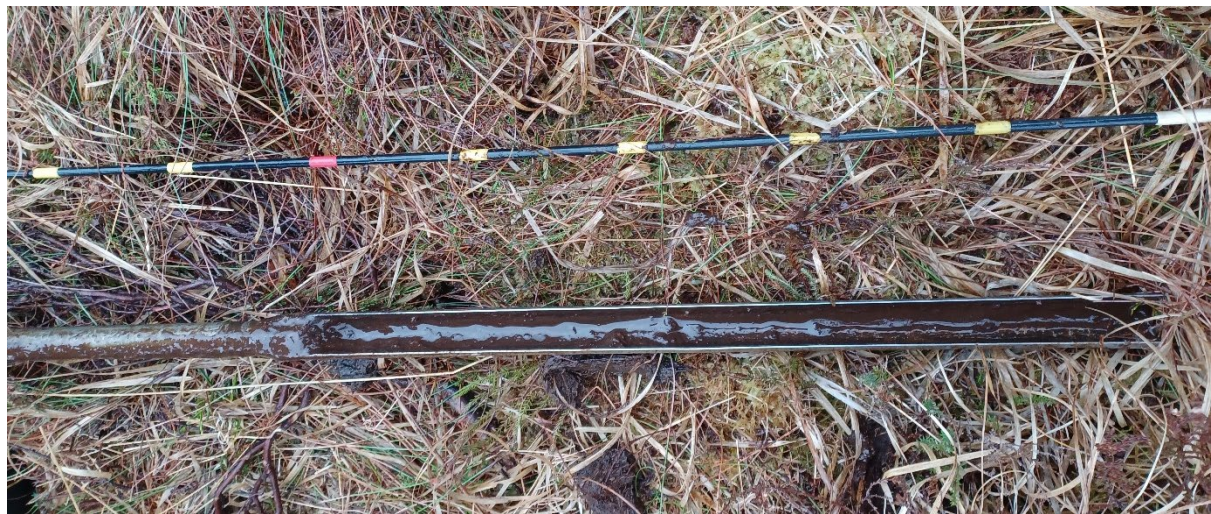
| Location: C2 | Depth: 1.50-2.00 m bgl | Date: 01/02/2024 |

Notes: Core interior showing that peat was too wet to obtain a proper core. The small amount able to be extracted shows that the peat is completely decomposed with no discernible plant structure.

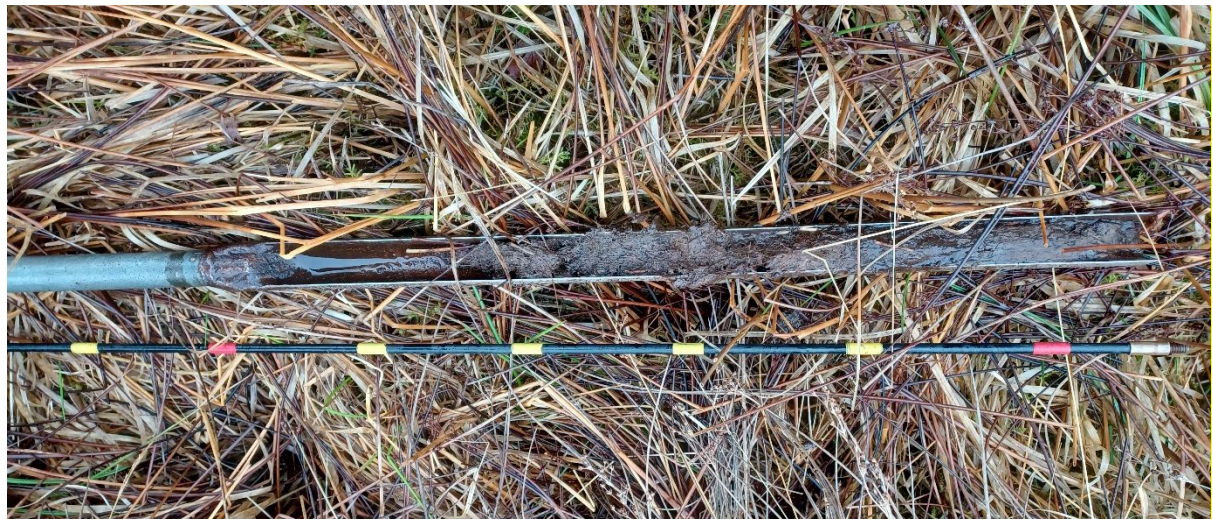
| Location: C3 | Depth: 0.00-0.50 m bgl | Date: 01/02/2024 |

Notes: Core interior showing almost entirely undecomposed peat with easily identifiable plant remains overlying moderately decomposed peat with quite indistinct plant remains.

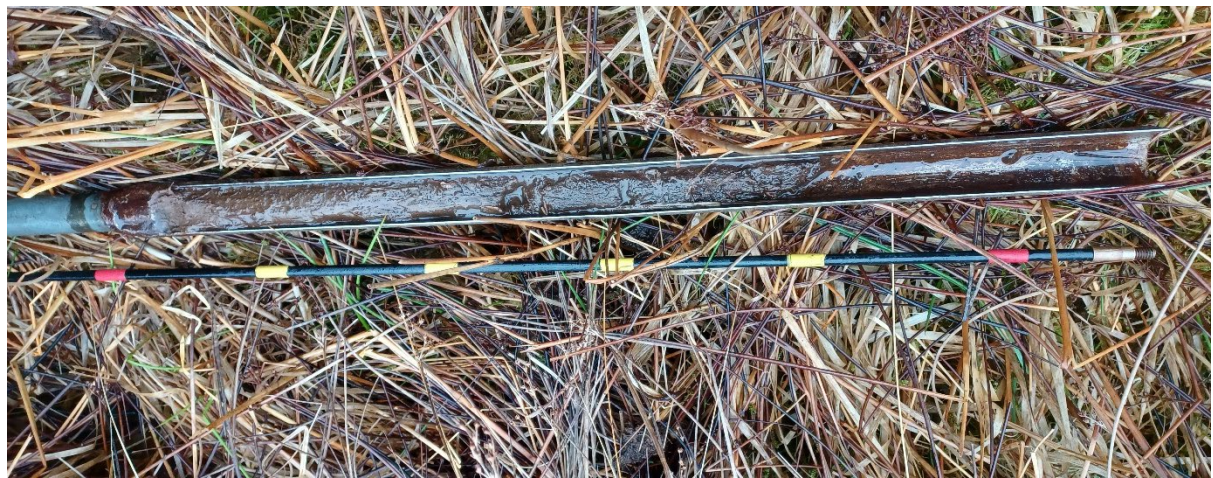
| Location:C3 | Depth: 0.50-1.00 m bgl | Date: 01/02/2024 |

Notes: Core interior showing moderately decomposed peat to moderately highly decomposed peat with quite indistinct to very indistinct plant structure. This is overlying highly decomposed peat with very faintly recognisable plant structure.

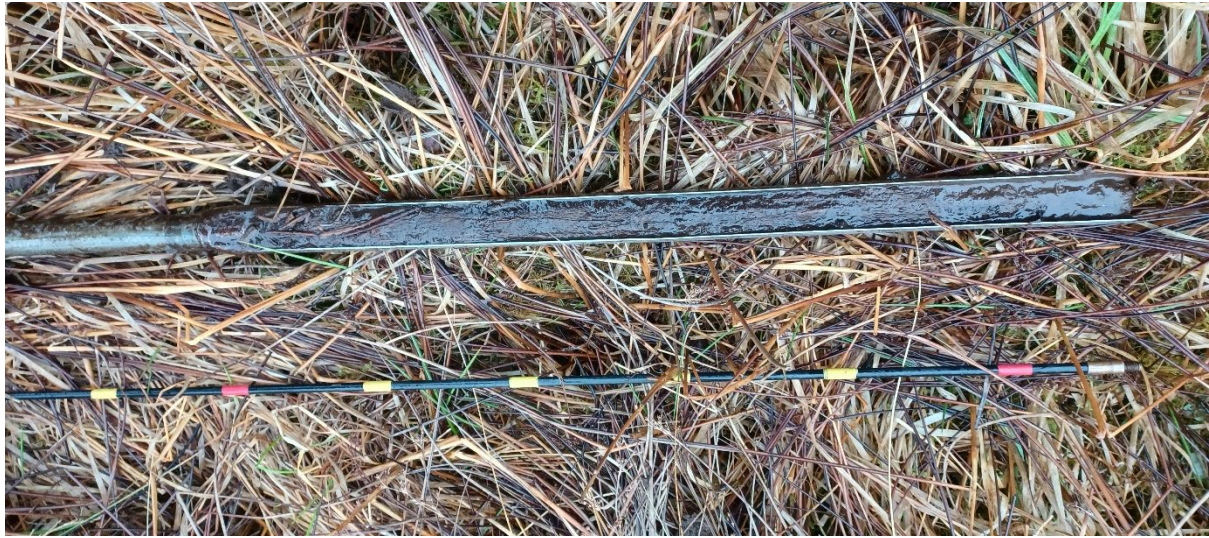
| Location: C3 | Depth: 1.00-1.50 m bgl | Date: 01/02/2024 |

Notes: Core interior showing highly decomposed peat with very faintly recognisable plant structures.

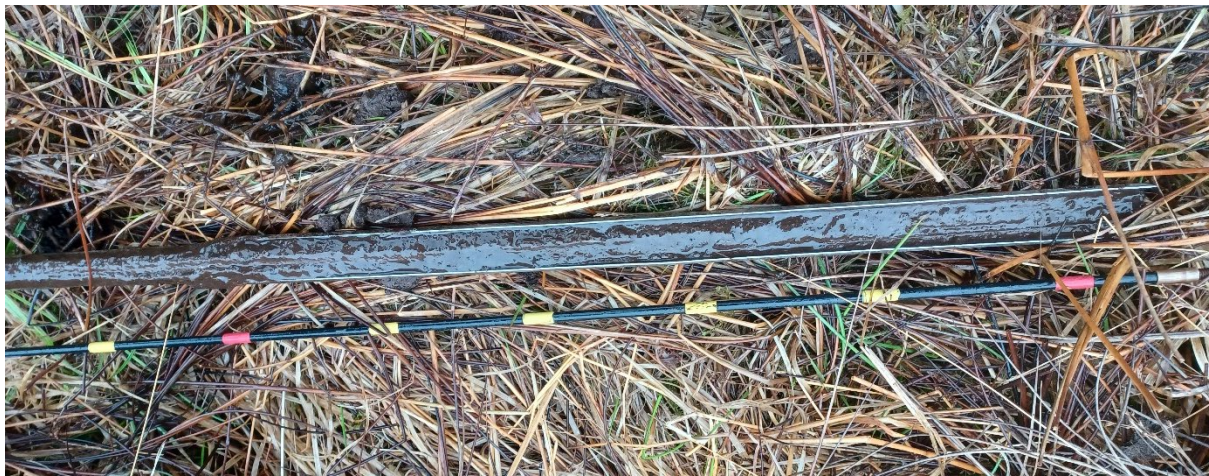
| Location: C3 | Depth: 1.5-2.00 m bgl | Date: 01/02/2024 |

Notes: Core interior showing very highly decomposed peat with very indistinct plant structures overlying practically fully decomposed peat with hardly any recognisable plant structure.

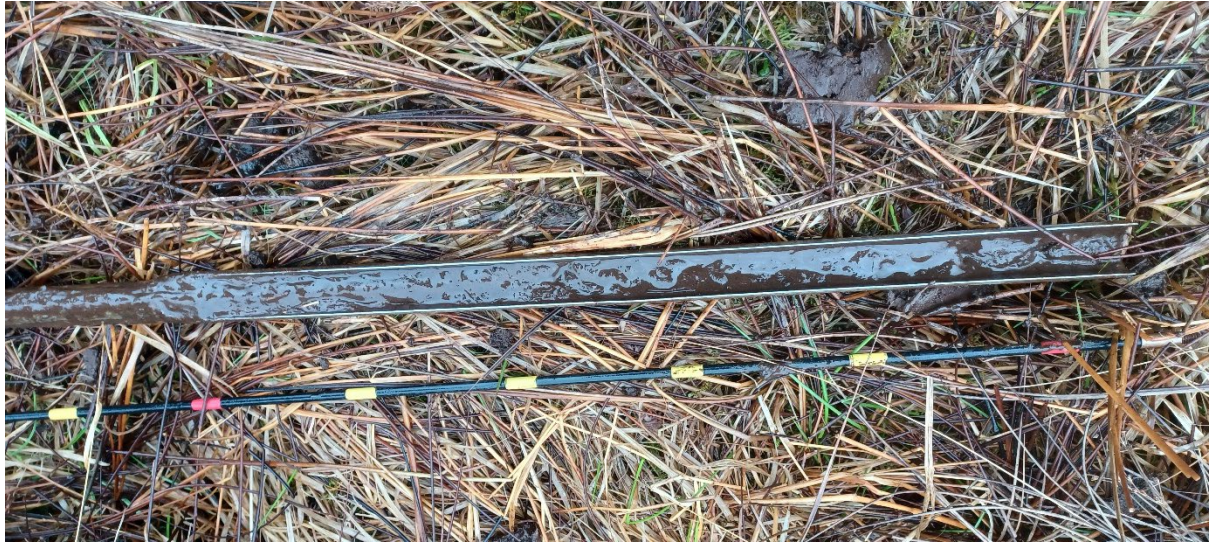
| Location: C3 | Depth: 2.00-2.50 m bgl | Date: 01/02/2024 |

Notes: Core interior showing practically fully decomposed peat with hardly any recognisable plant structure overlying completely decomposed peat with no discernible plant structure.
